# Manhole Inspection Summary

Manhole # S23C1\_007MH

Insp Date: **7/3/08 10:38 AM**

**Location** Address: **2404 Huron St**

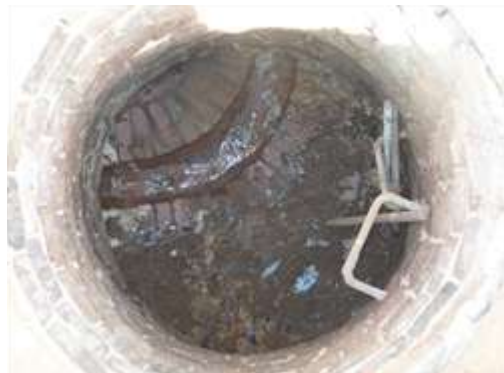
Top View

**Frame** Offset: **0** (in.) Condition: ☐ Sound ☐ Cracked ☒ **Leaks**

Condition: ☐ Sound ☐ Cracked ☐ Root Intrusion ☐ Loose Brick ☒ **Deteriorated**
